# **MALAYSIAN CONSTRUCTION RESEARCH JOURNAL (MCRJ)**

**Volume 39 | No. 1 | 2023**

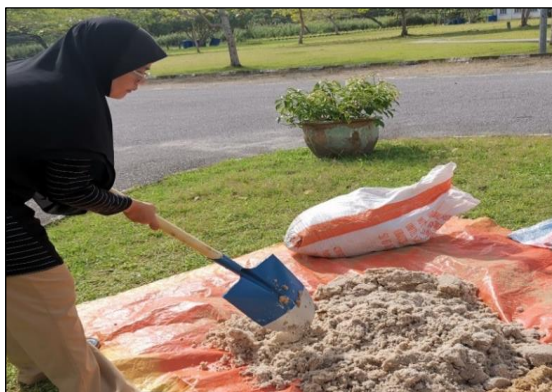
**Figure 1.** Drying of Sago Waste

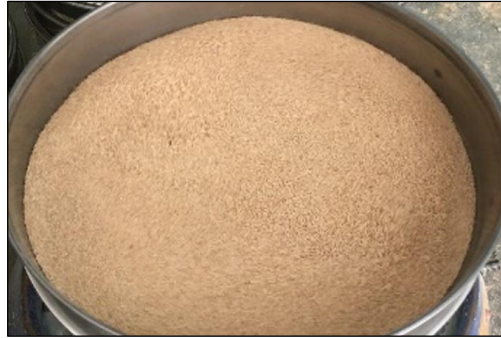
After drying, the sago waste was grinded and sieved using a 300  $\mu\text{m}$  sieve to produce sago fine waste (SFW) as shown in Figure 2.

**Figure 2.** Sago Fine Waste (SFW)

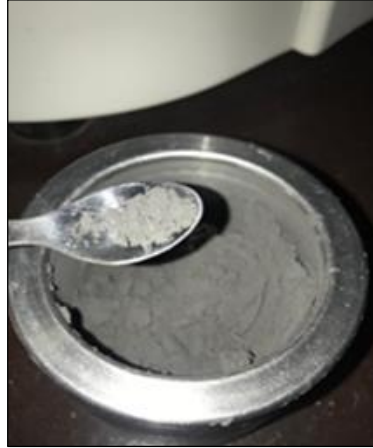
The machine can grind raw materials from bamboo to produce ash with a size of  $<45\ \mu\text{m}$  complying with the requirement of ASTM C618. The material was processed using a Ball Mill machine at a speed of 350 rpm for 10 minutes for every 100 grams of bamboo ash preparation as shown in Figure 1. After that, it was isolated into airtight plastic to ensure that it is always dry and not mixed with foreign matter.

**Figure 1.** Bamboo Ash After the Grinding Process

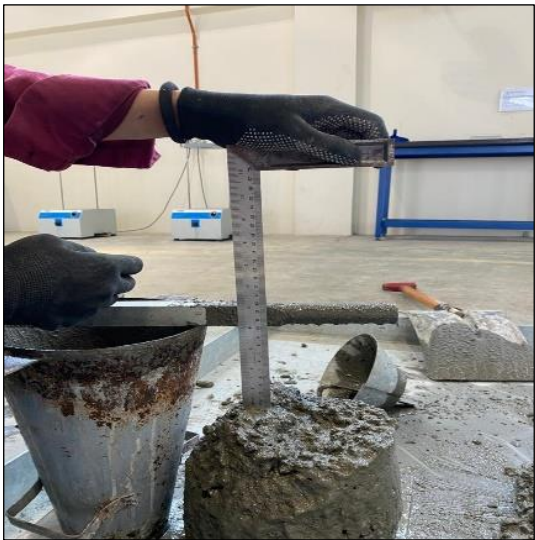
**Figure 2.** The Slump Test on Concrete Mix Design

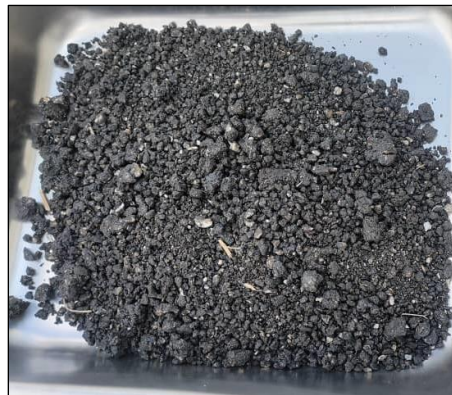
**Figure 1.** RAP That Passed Through a Sieve Size of 4.75 mm

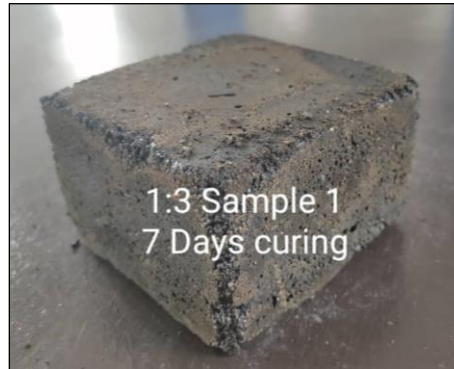
**Figure 2.** A SIPB Sample

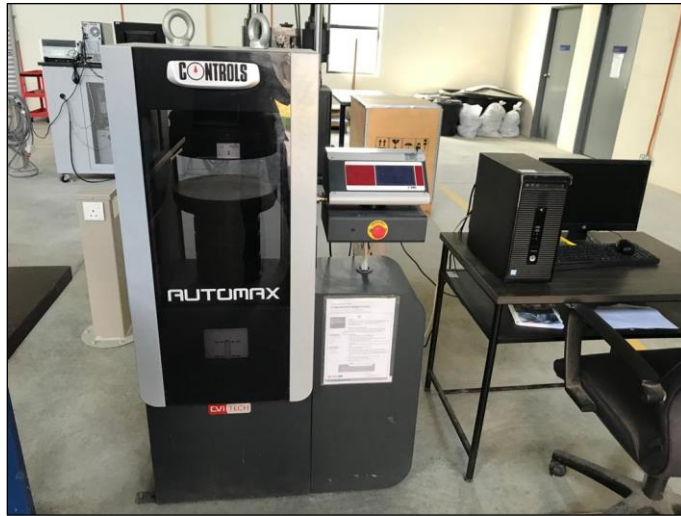
**Figure 3.** Compression Test Machine
