SUBMITTED TO CIDB MALAYSIA | JULY 2012

- HIGH FREQUENCY WELDED LIGHT GAUGE STEEL STRUCTURE (HFW H SECTION)
- AUTOCLAVED LIGHTWEIGHT CONCRETE PANEL (ALCP)
- BESTA BOARD PANEL

WELL & ABLE (M) SDN BHD

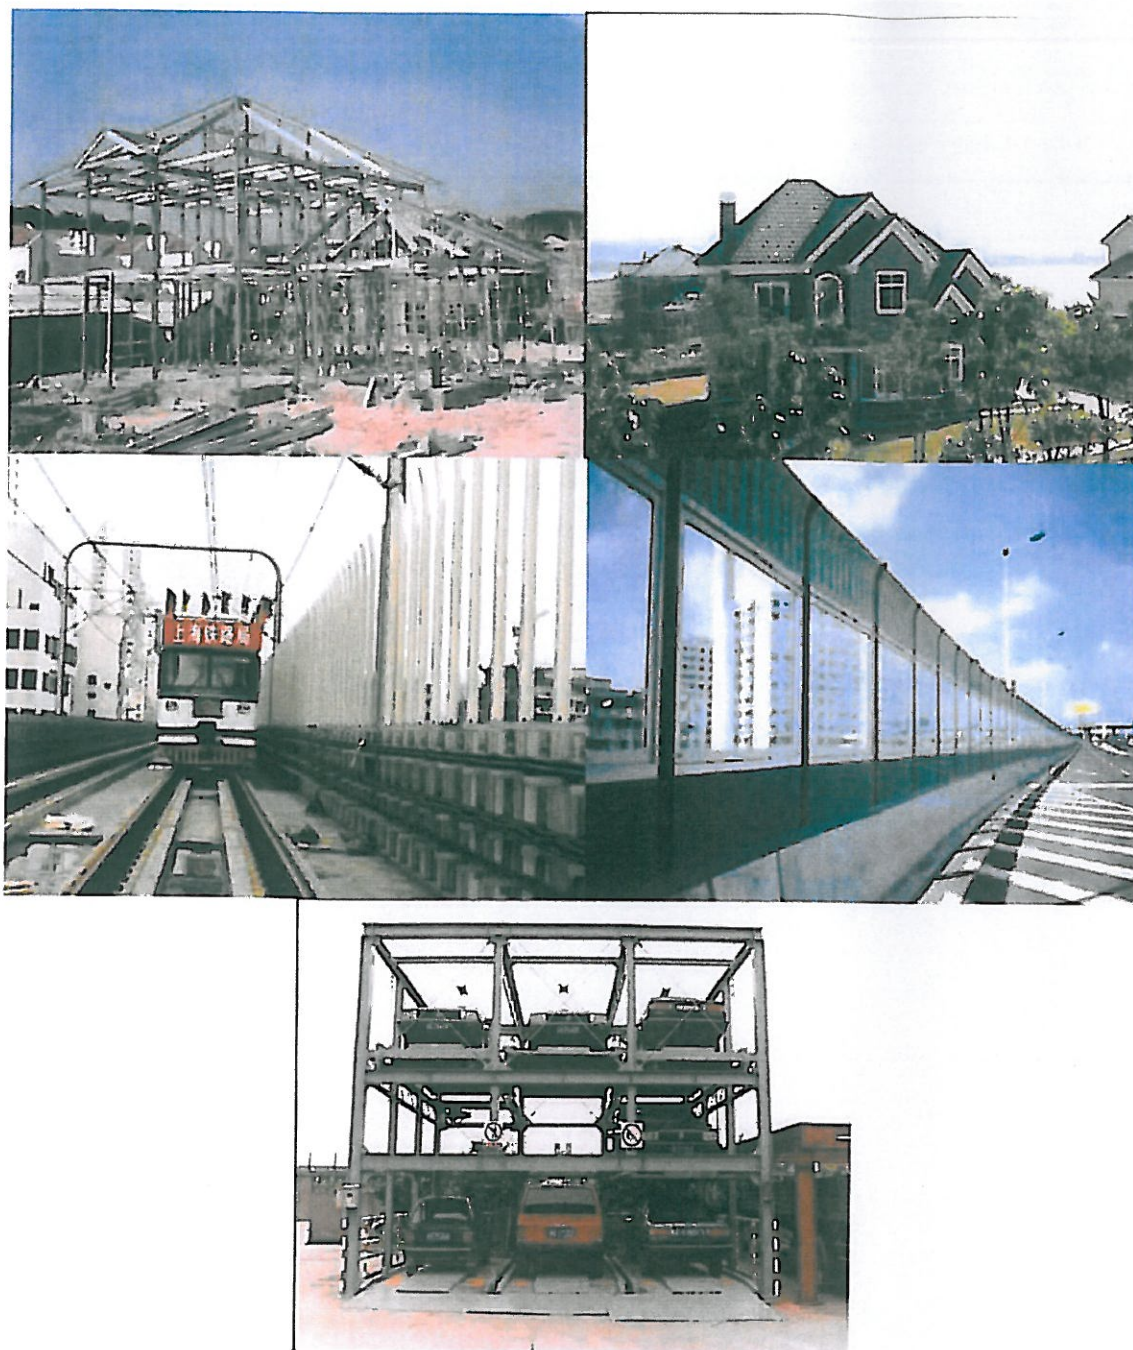
Figure 3 : HFW H Section used as main columns and beams for residential building and other application

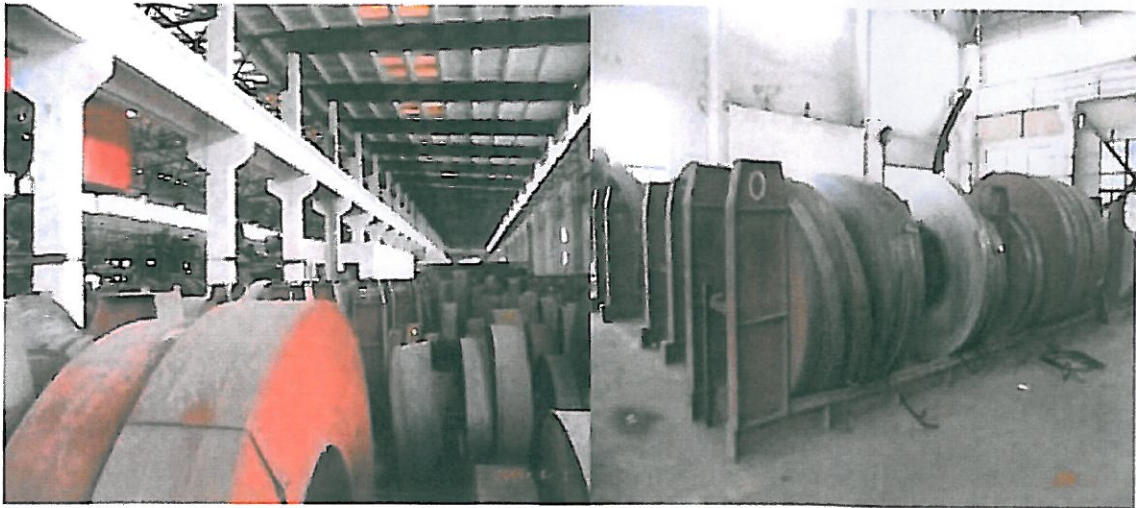
Figure 4: Special silted steel coil designed to the required thickness and width before being fed into the production line

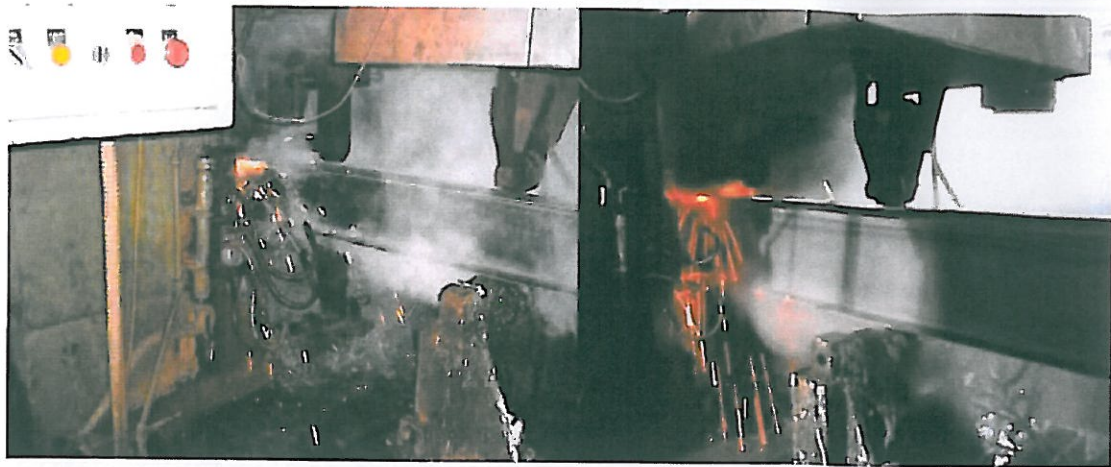
Figure 6 : Three steel strips welded by our high frequency welding process

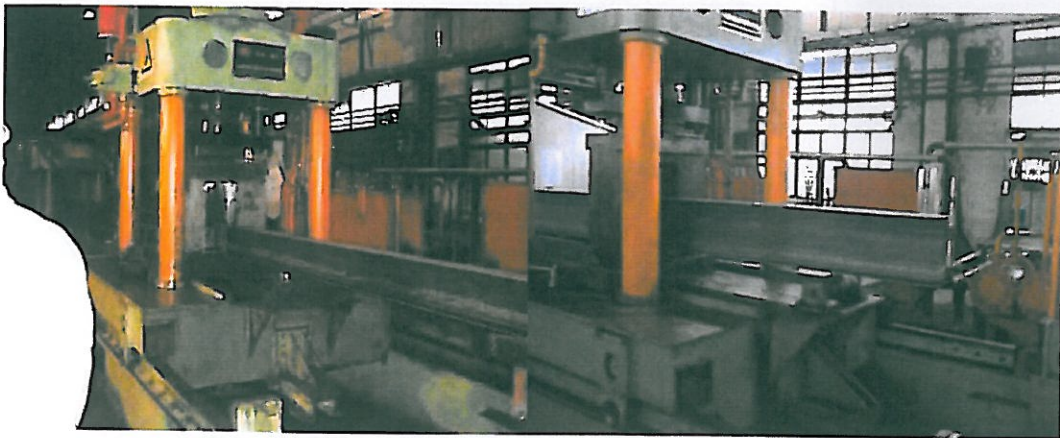
Figure 7 : After the stress relieve and strengthening of the welded H section, it will be cut to the desired length

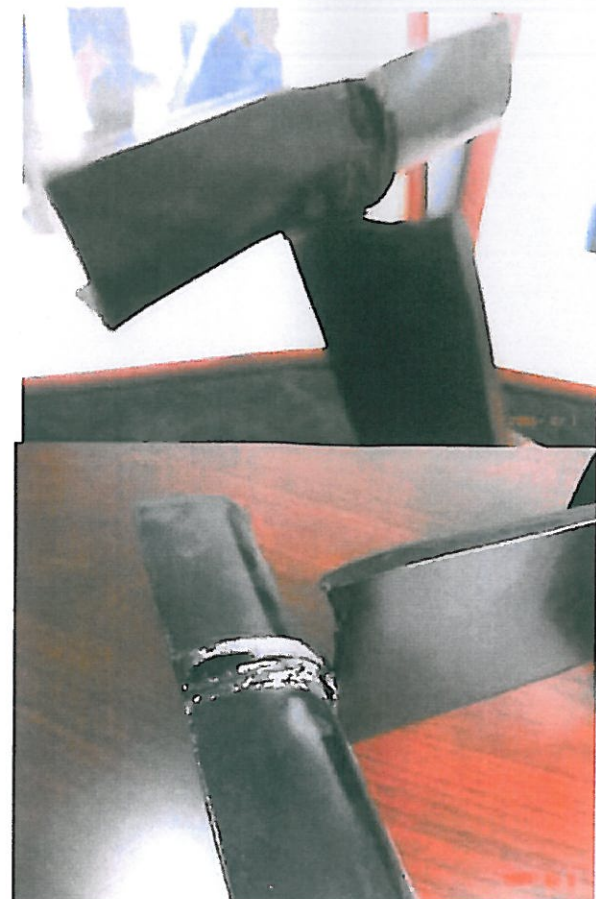
Figure 9 : Every batches that are produced will go through the pull-up test onsite

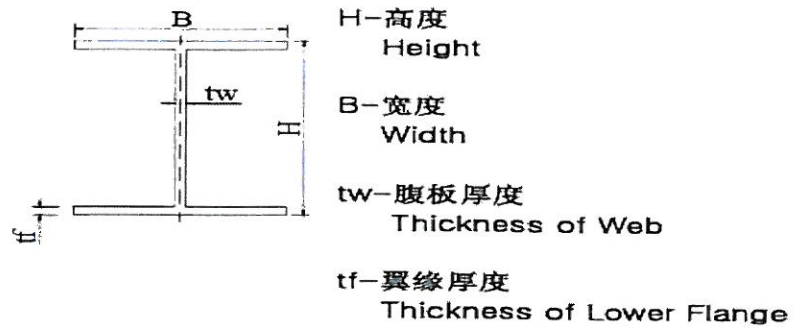
Equal Flange cross section

H	高度	Height	Min	60mm	Max	500mm
B	宽度	Width	Min	50mm	Max	250mm
tw	腹板厚度	Thickness of Web	Min	2.2mm	Max	8.0mm
tf	翼缘厚度	Thickness of Flange	Min	2.3mm	Max	10.0mm

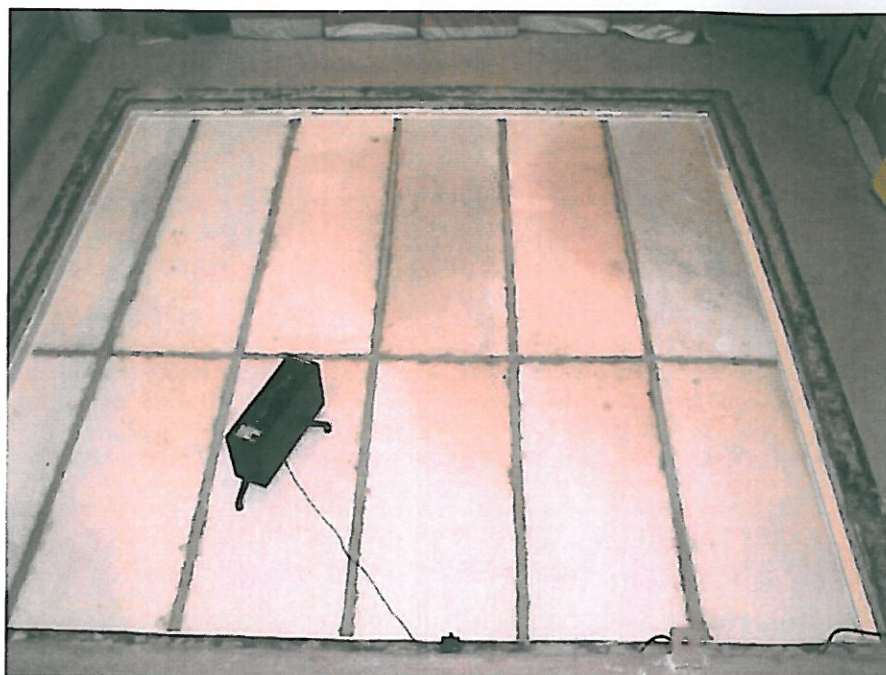
Figure 2 : Test setup of impact machine on floor panel system

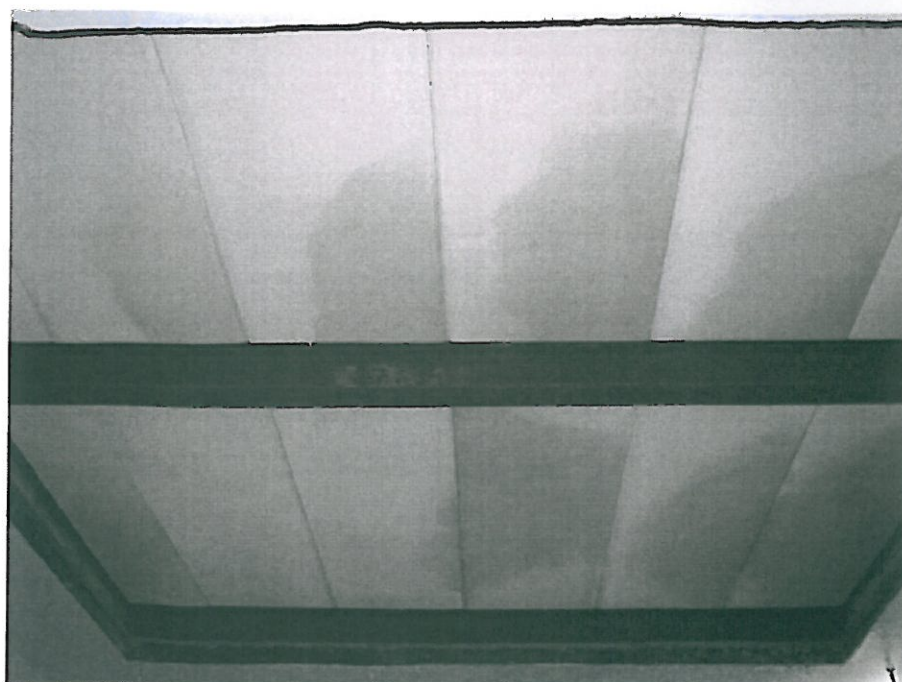
Figure 3 : Test setup of floor panel system installed on top of the reverberation room

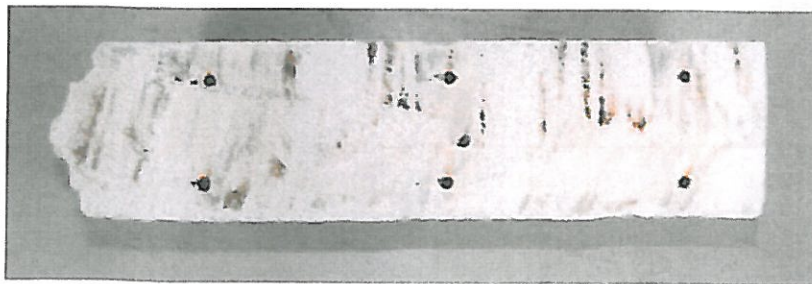
Figure 4 : Joint Detail and Cross Section of ALC wall panel

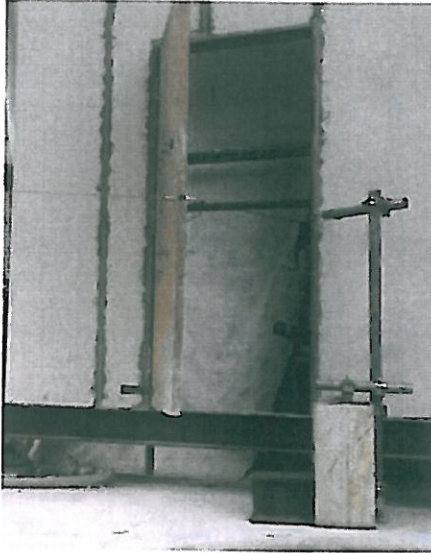
Door Slamming Test

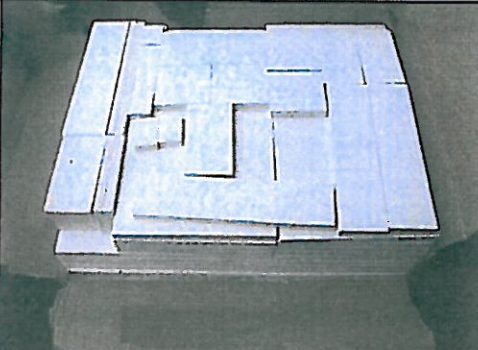
<p>"BESTA" Magnesium Oxide (MgO) boards of thickness 16mm, cut to the required size were received on 03/11/2008.</p>
<p>Photo 3.</p>

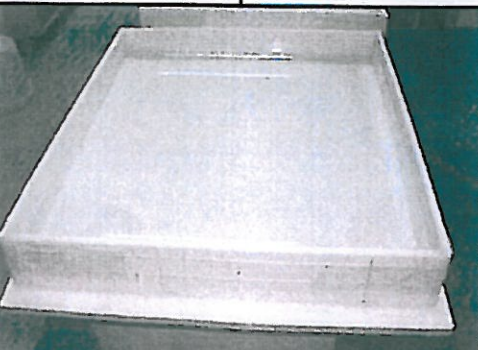
<p>Physical and Mechanical Properties - Water-tightness test in progress:</p> <p>MgO boards of 16mm thick cut specimens - 22 inch x 18 inch (559mm x 457mm). Water height of 2 in (50mm) maintained above the top surfaces at $23 \pm 2^{\circ}\text{C}$ and $50 \pm 5\%$ relative humidity for the 24 hours test.</p>

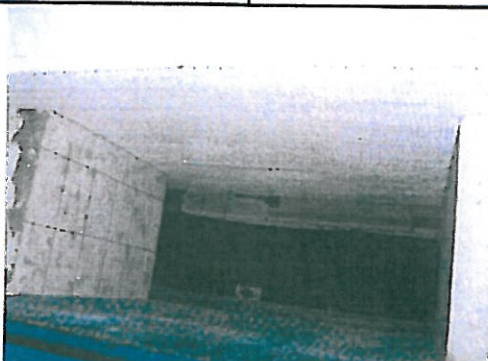
<p>Physical and Mechanical Properties - Water-tightness test.</p> <p>Test in progress: After 24 hours, no sign of water droplet or dampness on the underside of test specimens was observed.</p>
<p>Photo 5.</p>

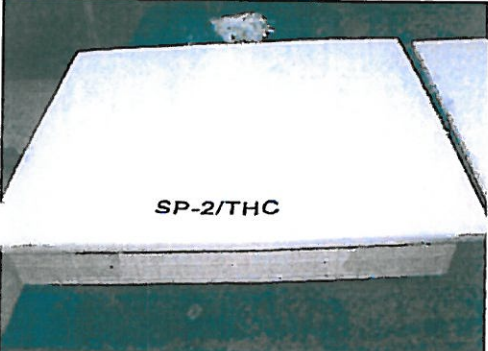
<p>Physical and Mechanical Properties in the lab for water tightness test.</p> <p>Photo shows the underside of the specimens No apparent defect was observed of all the three test specimens at the conclusion of water-tightness test after 24 hours.</p>
<p>Photo 6.</p>

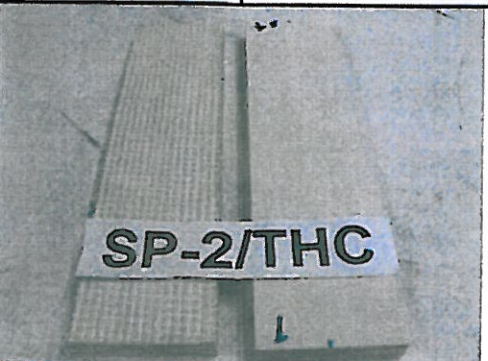
<p>Physical and Mechanical Properties - Moisture Movement test.</p> <p>Cut test specimens of 305 x 76mm x 16mm MgO board.</p>

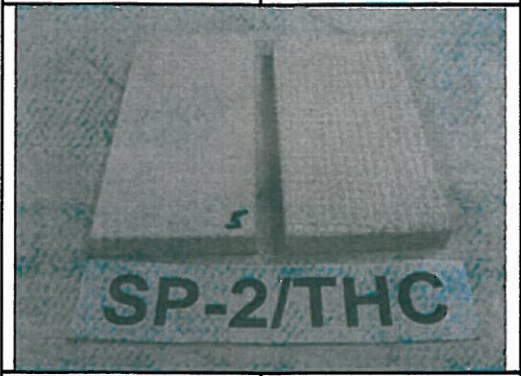
<p>Physical and Mechanical Properties – Moisture Content test.</p> <p>Cut test specimens of 152 x 76mm x 16mm MgO board.</p>
<p>Photo 8.</p>

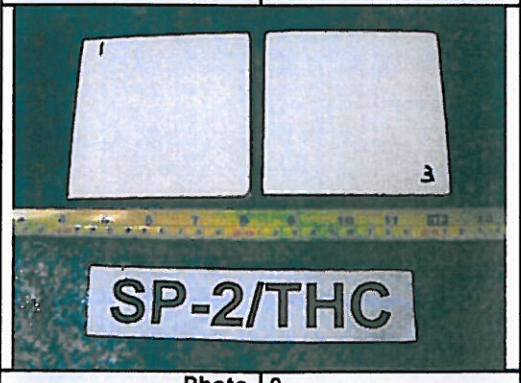
<p>Physical and Mechanical Properties – Water Absorption test.</p> <p>Cut test specimens of 100 x 100 x 16mm MgO board.</p>
<p>Photo 9.</p>

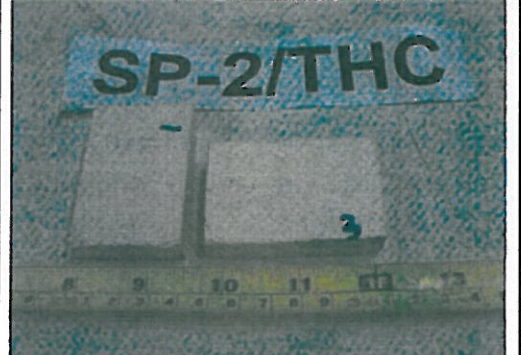
<p>Physical and Mechanical Properties – Density.</p> <p>Cut test specimens of 60 x 40mm x 16mm MgO.</p>

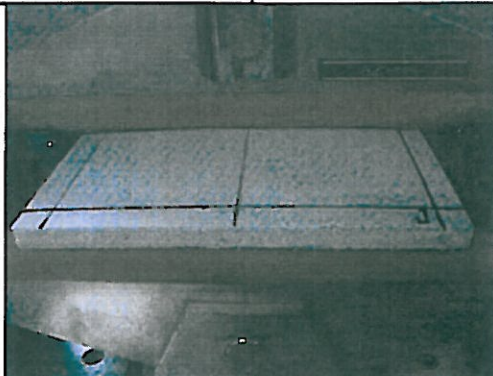
<p>Physical and Mechanical Properties – Bending Strength test.</p> <p>Photo shows the cut test specimen after conditioning and subjected to bending load supported at a span of 215mm.</p>
Photo 11.

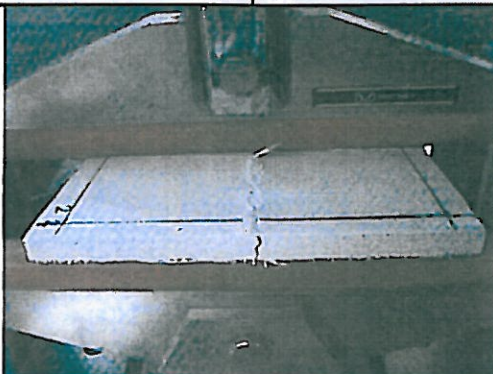
<p>Physical and Mechanical Properties – Bending Strength test.</p> <p>After 1st break, the fractured test specimens were assembled for a second bending test along an axis perpendicular to that used in the 1st test.</p>
Photo 12.

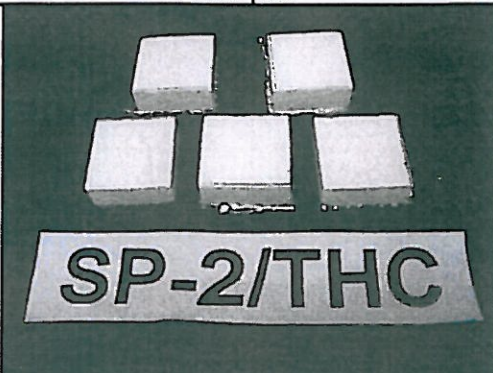
<p>Physical and Mechanical Properties – Linear Thermal shrinkage test.</p> <p>Cut test specimens of 35 x 35mm x 16mm MgO.</p>

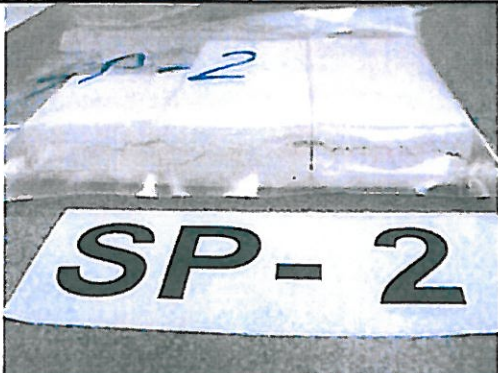
<p>Physical and Mechanical Properties – Linear Thermal shrinkage test .</p> <p>Photo shows cracks on the tested specimens of 35 x 35mm x 16mm MgO after 4 hours in furnace at 950 °C.</p>

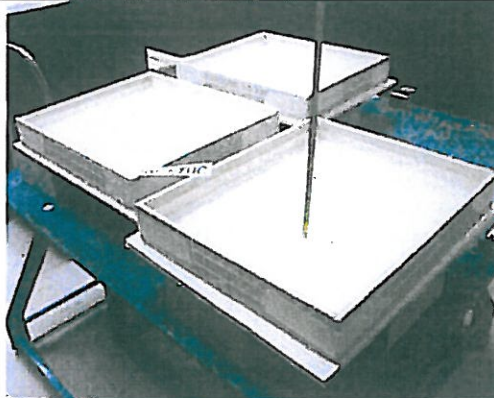
<p>Physical and Mechanical Properties - Water-tightness test.</p> <p>Test in progress : MgO boards of 10mm thick cut into test specimens of dimension 22 inch x 18 inch (559mm x 457mm) with Water height of 2 in (50mm) been maintained above the top surfaces at $23 \pm 2^{\circ}\text{C}$ and $50 \pm 5\%$ relative humidity for the 24 hours test.</p>
<p>Photo 2.</p>

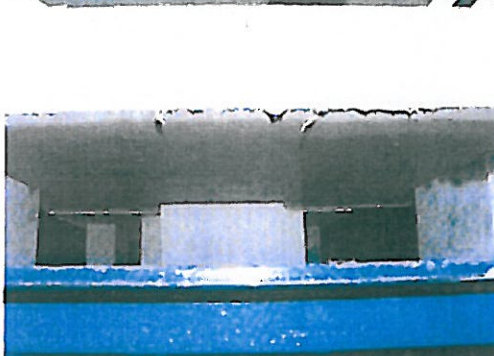
<p>Physical and Mechanical Properties - Water-tightness test.</p> <p>Test in progress: After about 5 hours, sign of water dampness started to appear on the underside of test specimens.</p>
<p>Photo 3.</p>

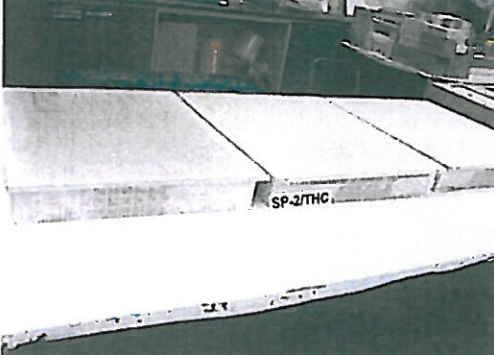
<p>Physical and Mechanical Properties in the lab for water tightness test.</p> <p>Photo shows the appearance of dampness on the underside of all the three (03) test specimens at the conclusion of water-tightness test after 24 hours.</p>

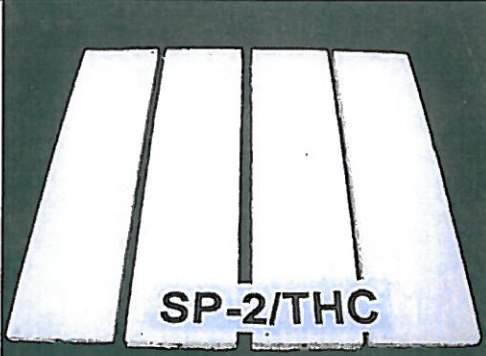
<p>Physical and Mechanical Properties – Moisture Movement test.</p> <p>Cut test specimens of 305 x 76mm x 10mm MgO board.</p>
<p>Photo 5.</p>

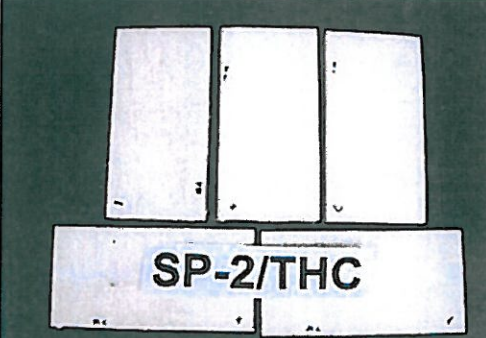
<p>Physical and Mechanical Properties – Moisture Content test.</p> <p>Cut test specimens of 152 x 76mm x 10mm MgO board.</p>
<p>Photo 6.</p>

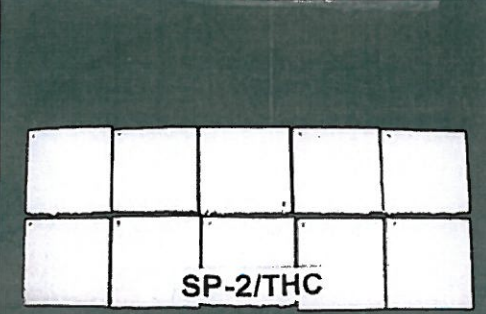
<p>Physical and Mechanical Properties – Water Absorption test.</p> <p>Cut test specimens of 100 x 100 x 10mm MgO board.</p>

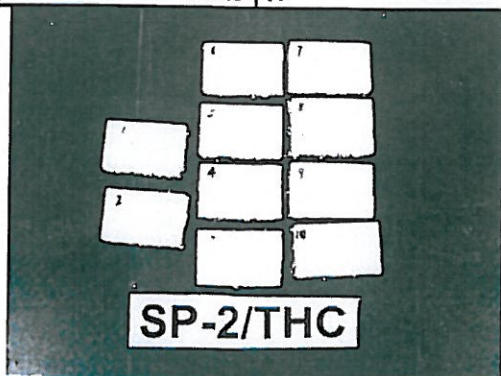
<p>Physical and Mechanical Properties – Density.</p> <p>Cut test specimens of 60 x 40mm x 10mm MgO.</p>
<p>Photo 8.</p>

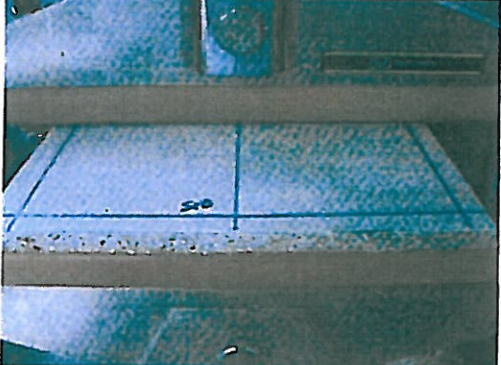
<p>Physical and Mechanical Properties – Bending Strength test.</p> <p>Photo shows the cut test specimens after conditioning and subjected to bending load supported at a span of 215mm.</p>
<p>Photo 9.</p>

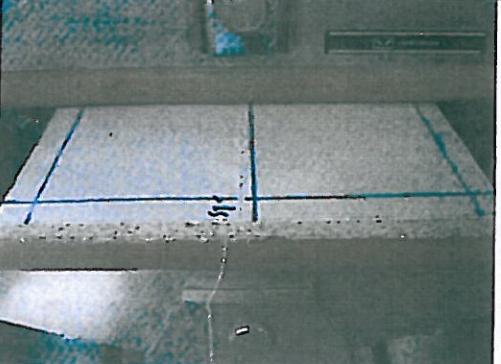
<p>Physical and Mechanical Properties – Bending Strength test.</p> <p>After 1st break, the fractured test specimens were assembled for a second bending test along an axis perpendicular to that used in the 1st test.</p>

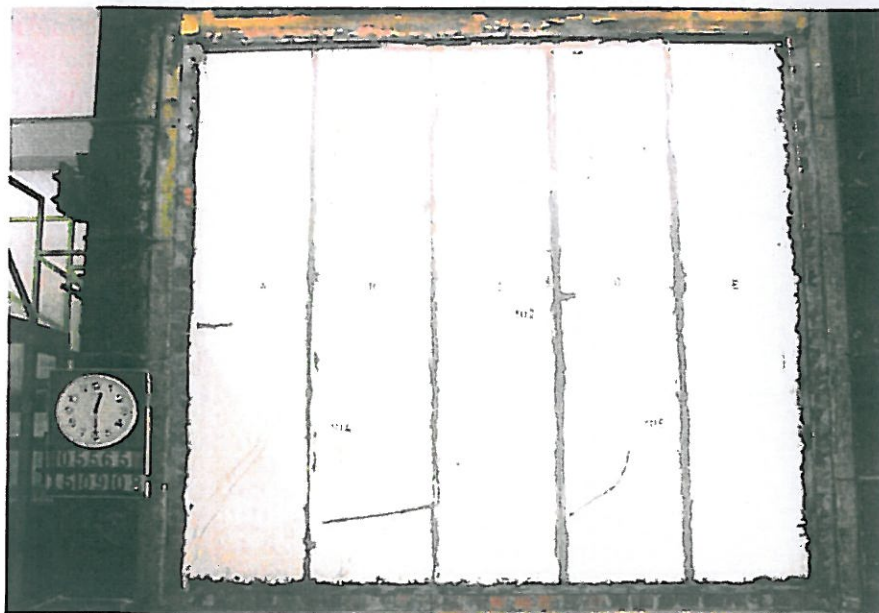
Plate 2: At about 30 minutes of test.

20:00	Increased inward deflections along its mid-height were measured.
30:00	Integrity of the wall observed to be intact.
60:00	No significance occurrence was observed. Integrity of wall remained intact.

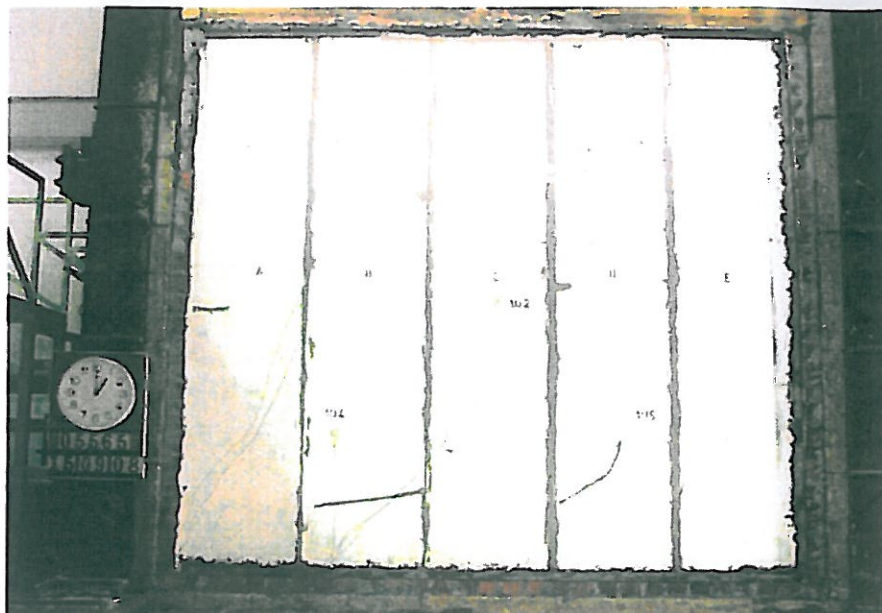
Plate 3: At about 60 minutes of test.

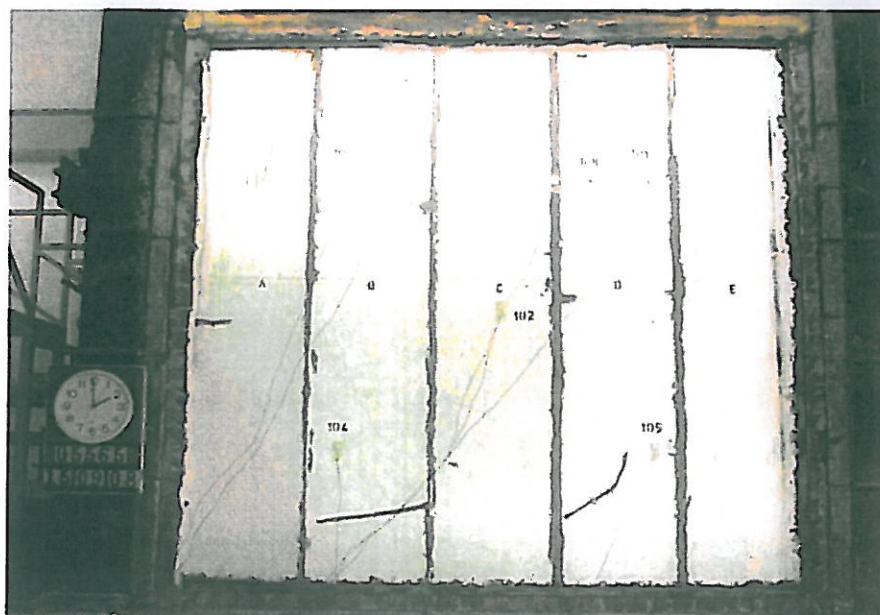
Plate 4: At about 120 minutes of test.

90:00	No changes observed.
120:00	Integrity remained intact and no significance changes observed.
167:00	A bulging light grey patch began to emerge on wall surface below thermocouple point 102.

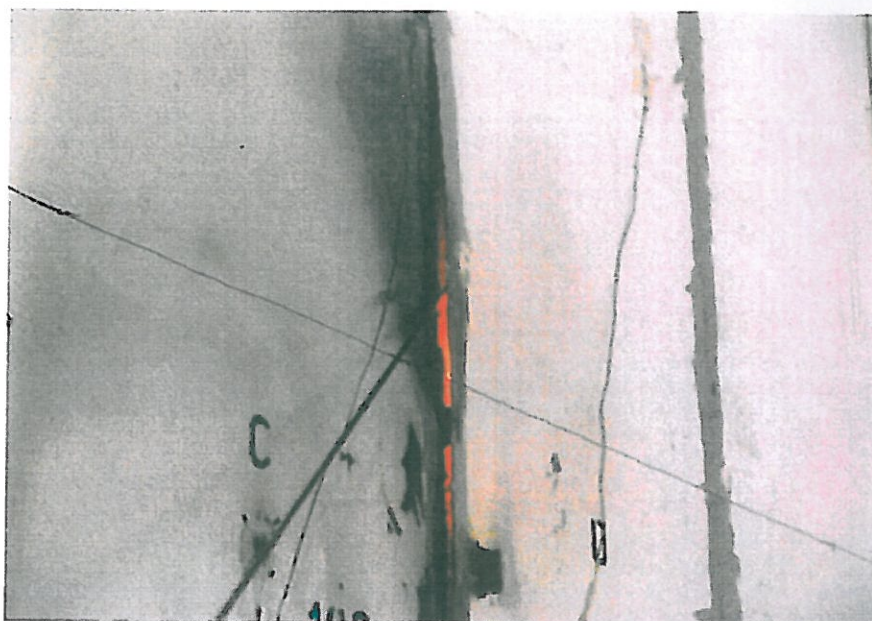
Plate 5: At about 200 minutes of test.

200:00	A 6mm gap gauge employed at through gap between panel C and D and was able to traverse vertically for 200mm in length.
202:00	A single 'boom' sound heard. Continuous flaming for more than 10 seconds was observed at gap mentioned at 200 minutes.

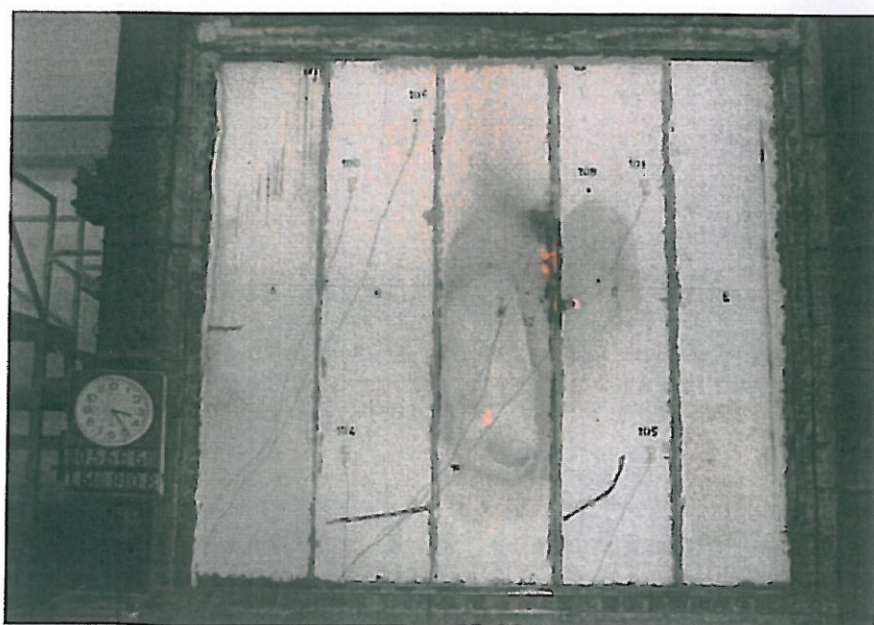
Plate 6: At about 204 minutes of test.

204:00	Test was terminated.

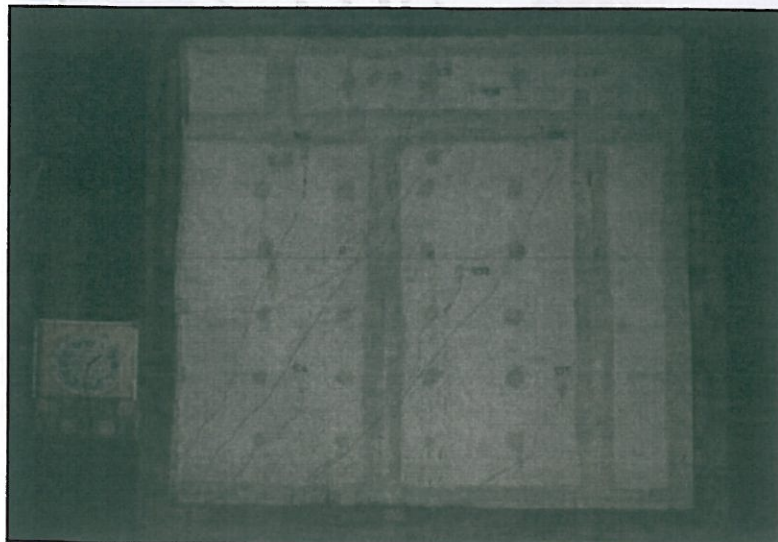
Plate 4 : At about 91 minutes of test

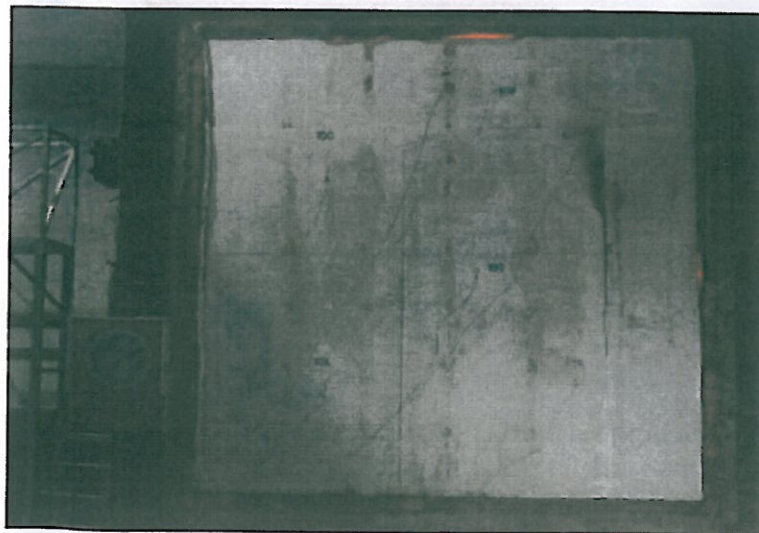
Plate 6 : At about 132 minutes of test.

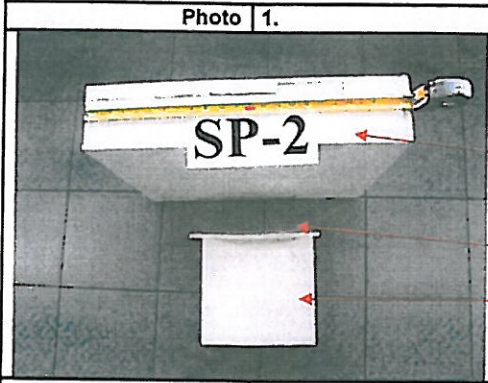
<p>Photo 1.</p>

<p>Physical and Mechanical Properties –Thermal conductivity test specimens :</p> <p>600 x 600 x 128 mm Sandwich perlite w/air channel panel.</p> <p>300 x 300 x 10 mm MgO board.</p> <p>300 x 300 x 100 mm Sandwich perlite panel.</p>
<p>Photo 2.</p>

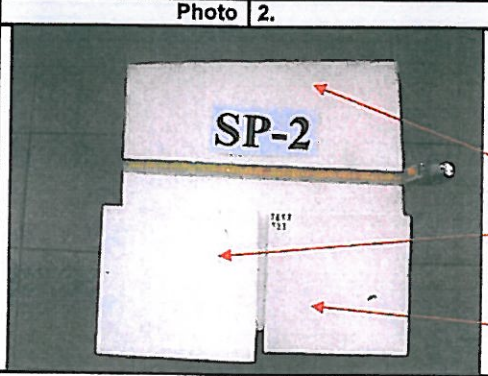
<p>Physical and Mechanical Properties –Thermal conductivity test specimens :</p> <p>600 x 600 x 128 mm Sandwich perlite w/air channel panel.</p> <p>300 x 300 x 100 mm Sandwich perlite panel.</p> <p>300 x 300 x 10 mm MgO board.</p>

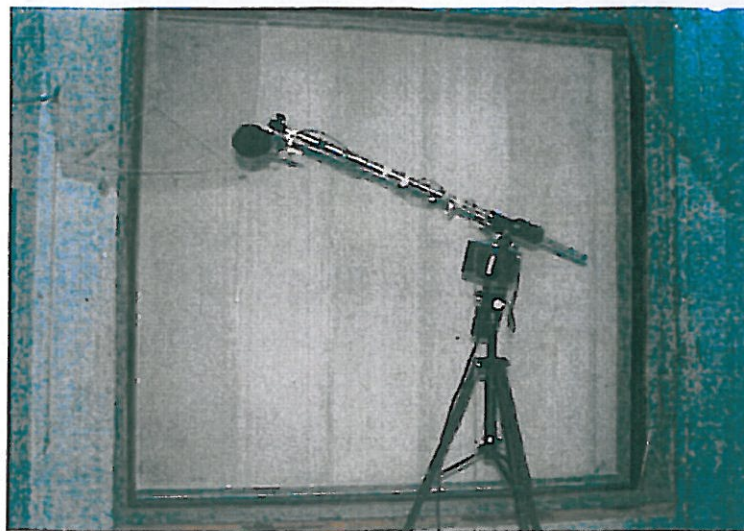
Figure 3 : "Besta" composite mineral board system facing the receiving room

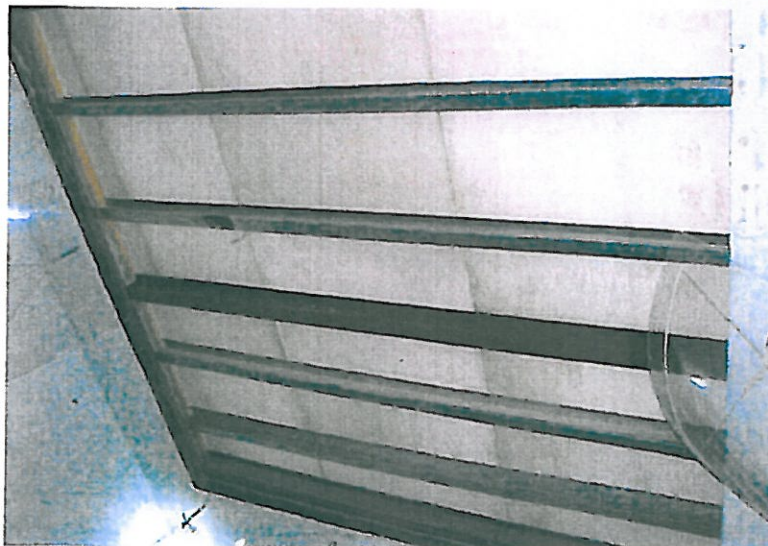
Figure 3 : Test setup of the "Besta" board panel system (underside) facing the receiving room

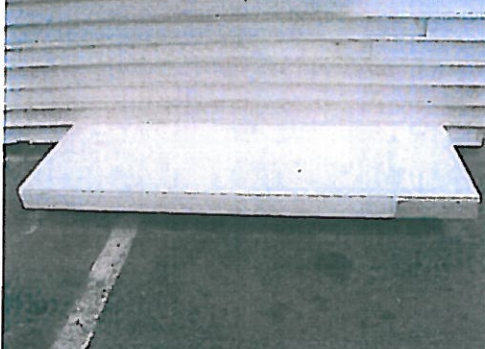
Photo	1.

<p>Typical sample of "BESTA" MgO sandwich perlite wall panels of 100mm overall thickness, were received on 11/07/2008.</p>
Photo	2.

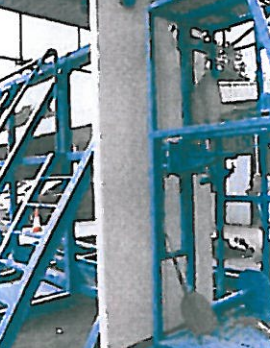
<p>The junction wall section, made up of two (02) panels of width 600mm sandwich panels erected side-by-side.</p>

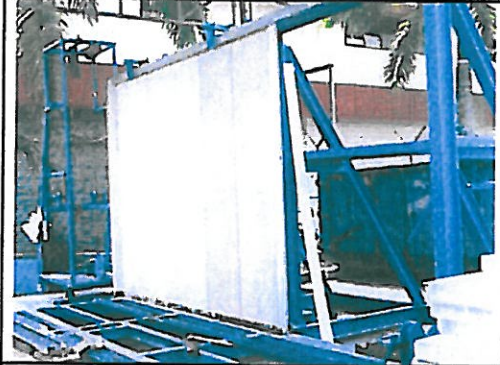
Photo 4.

The installation of the main wall section – in progress.
Photo 5.

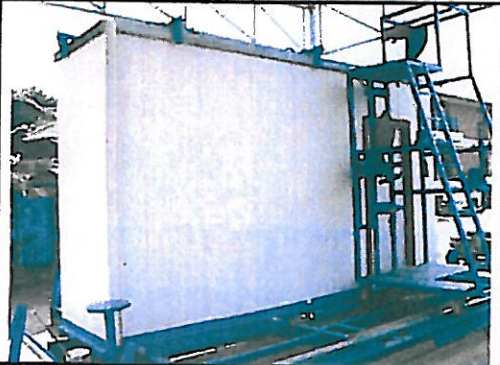
General view of the completed "Besta" MgO sandwich perlite wall panel system under curing and before the application of emulsion paint coating.
Photo 6.

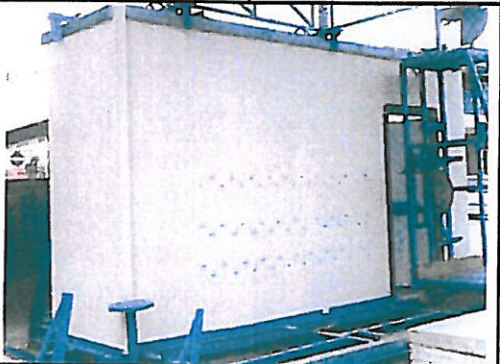
<p>The second layer of off white emulsion paint coating been applied.</p> <p>Test locations on the surfaces of both the main and junction wall sections to undergo stiffness, surface and perforation by small hard body impact were marked.</p>

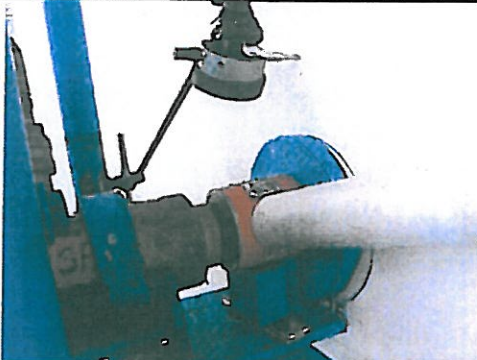
<p>Photo 7.</p>

<p>Performance testing:</p> <p>Annex A: Stiffness Test on 11th July 2008.</p>
<p>Photo 8.</p>

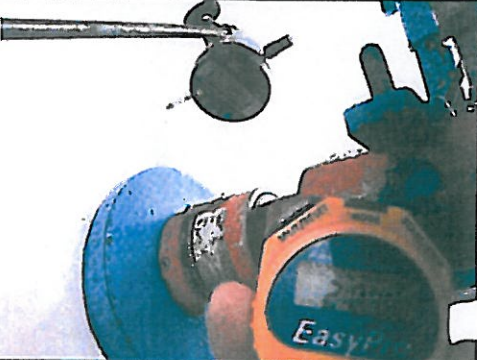
<p>Performance testing :</p> <p>Annex A: Stiffness Test - Photo shows maximum deflection reading of 1.761 mm under 500N load after 2 minutes.</p>
<p>Photo 9.</p>

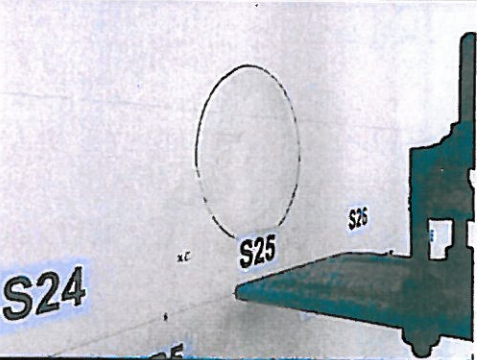
<p>Performance testing :</p> <p>Annex A: Stiffness Test - Photo shows no visible crack or other damage to the wall during and after the test.</p>

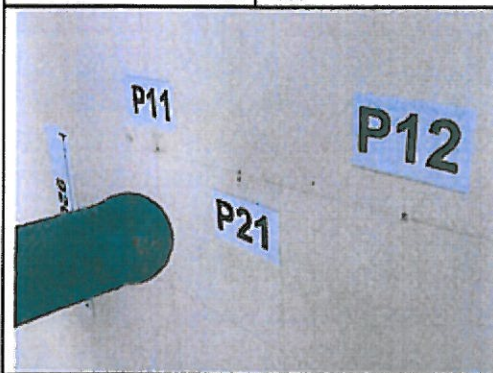
<div data-bbox="448 470 576 495" data-label="Caption"> <p>Photo 13.</p> </div>

<div data-bbox="790 504 1190 560" data-label="Text"> <p>Performance testing – Perforation Test (Annex D) :</p> </div> <div data-bbox="790 591 1208 620" data-label="Text"> <p>P21 – for perforation test at 30 Nm.</p> </div>
<div data-bbox="448 866 566 891" data-label="Caption"> <p>Photo 14.</p> </div>

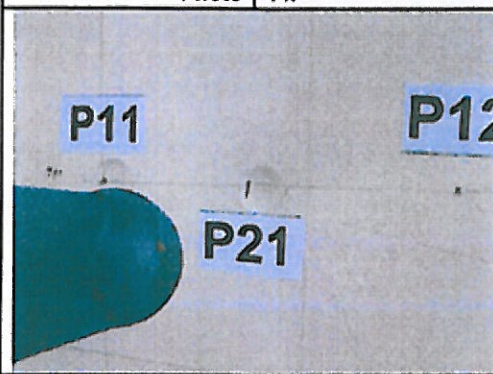
<div data-bbox="790 902 1189 960" data-label="Text"> <p>Performance testing – Perforation Test (Annex D) :</p> </div> <div data-bbox="790 990 1171 1048" data-label="Text"> <p>P21 – after perforation test at 30 Nm.</p> </div>
<div data-bbox="448 1263 563 1288" data-label="Caption"> <p>Photo 15.</p> </div>

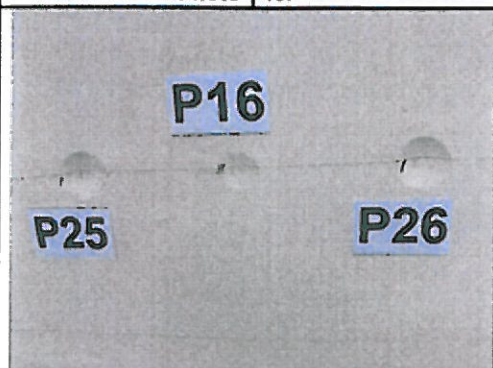
<div data-bbox="790 1296 1185 1355" data-label="Text"> <p>Performance testing – Perforation Test (Annex D) :</p> </div> <div data-bbox="790 1384 1152 1473" data-label="Text"> <p>Photo shows the indentation at points P16, P25 & P26 after impacts.</p> </div>

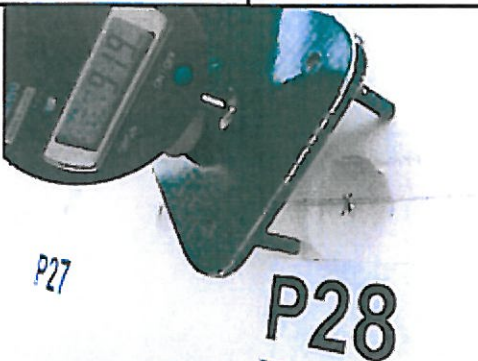
<p>Photo 16.</p>

<p>Performance testing – Surface Damage (Annex B) and Perforation Test (Annex D) :</p> <p>Instrument for depth of indentation measurement.</p>
<p>Photo 17.</p>

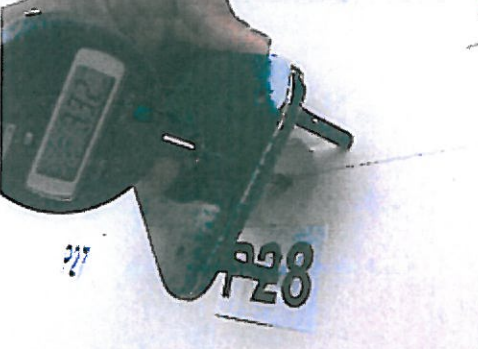
<p>Performance testing – Surface Damage (Annex B) and Perforation Test (Annex D) :</p> <p>Measuring the depth of Indentation at point P28.</p>
<p>Photo 18.</p>

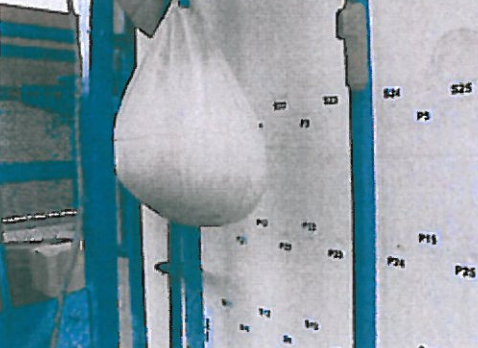
<p>Performance testing – Resistance to damage by impact from a large soft body (Annex C):</p> <p>Photo shows the setup of large soft body impact test.</p>

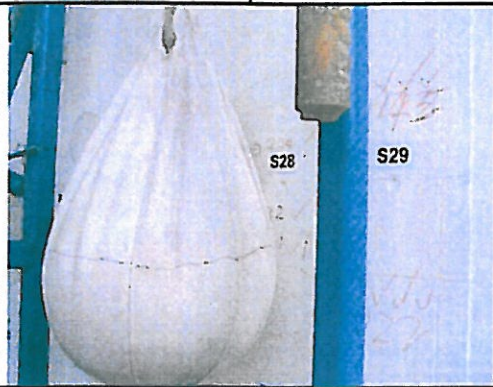
Photo 19.

<p>Performance testing – Resistance to structural damage by multiple impacts from a large soft body (Annex E) :</p> <p>No visible crack or other damage occurred to the wall during and after the test.</p>
Photo 20.

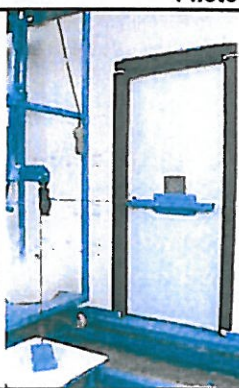
<p>Performance testing – Effect of door slamming (Annex F) :</p> <p>Photo shows the setup of door leaf (60Kg) to be opened to 60° angle and slam onto the door frame by a 15Kg weight.</p>
Photo 21.

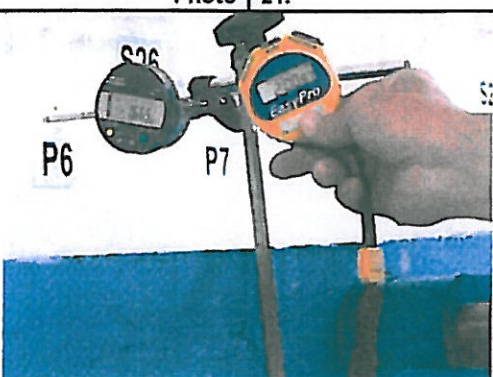
<p>Performance Testing – Resistance to crowd pressure (Annex G) :</p> <p>Residual deformation of -1.87 mm after the 3.0 KN per meter run horizontal load was released for 5 minutes. No damage occurred.</p>

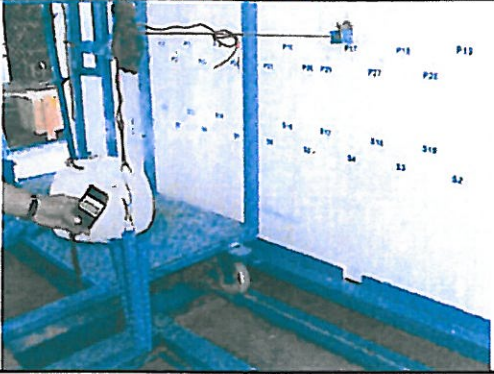
<p>Photo 22.</p>

<p>Performance Testing – Lightweight anchorage pull-out test (Annex H) :</p> <p>Photo shows the setup of pull-out test in progress.</p>
<p>Photo 23.</p>

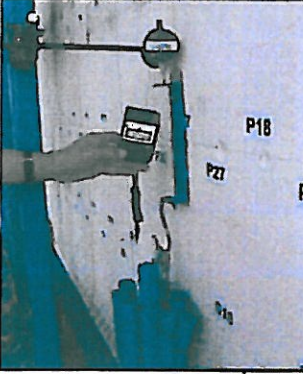
<p>Performance Testing – Lightweight anchorage pull-down test (Annex J) :</p> <p>Displacement of 0.270 mm after subjected to a pull-down load of 250N. The pull-up shim is intact. No damage occurred.</p>
<p>Photo 24.</p>

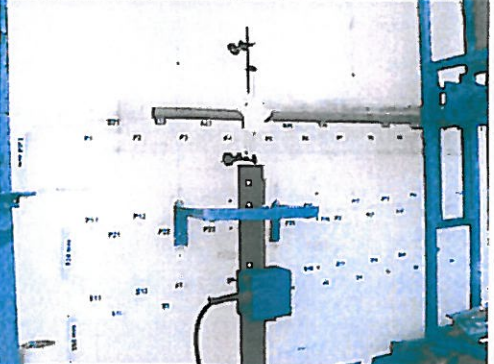
<p>Performance Testing – Heavyweight anchorage (wash basin) eccentric downward loading test:</p> <p>Annex K: Photo shows heavyweight downward loading (wash basin) test in progress.</p>

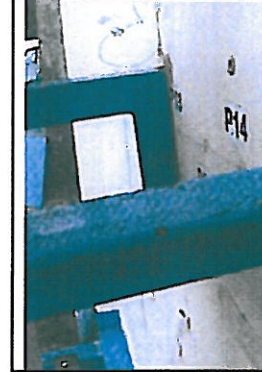
Photo	25.

<p>Performance Testing – Heavyweight anchorage (wash basin) eccentric downward loading test:</p> <p>Annex K: Shim plate intact, gaps observed around the upper anchorage bracket and wall. A fine crack was also visible on the wall besides the upper top left end of the bracket.</p>
Photo	26.

Remark : Shim plate intact but gaps between bracket and wall were noted, (see photo 25), a fine crack also found the top left anchorage point (see photo 28) after the test./dislodgment of its parts or fixings after the test.

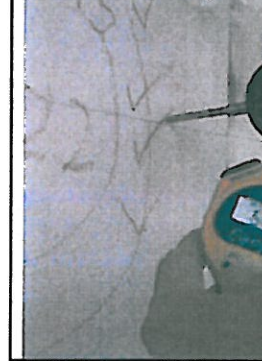
<p>Performance Testing – Heavyweight anchorage (wash basin) eccentric downward loading test:</p> <p>Annex K: Gauge reading at front wall shows deflection at 1.2m height as - 0.11mm after 5 minutes.</p>
Photo	27.

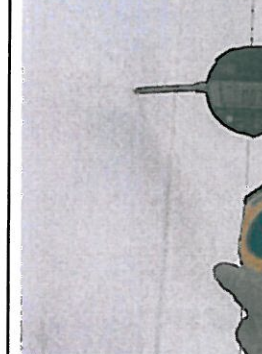
<p>Performance Testing – Heavyweight anchorage (wash basin) eccentric downward loading test:</p> <p>Annex K: Gauge reading at front wall shows deflection at 1.75m height as - 0.077mm after 5 minutes.</p>

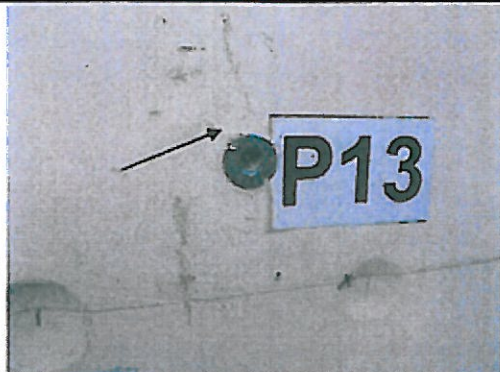
<p>Photo 28.</p>

<p>Performance Testing – Heavyweight anchorage (wash basin) eccentric downward loading test:</p> <p>Annex K: Photo shows a fine crack on the wall around the anchorage point (top left) after test.</p>
<p>Photo 29.</p>

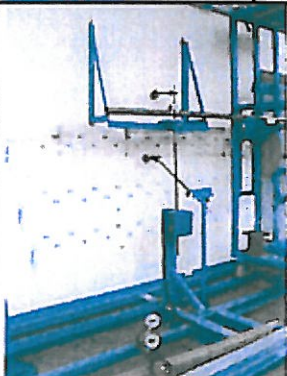
<p>Performance Testing – Heavyweight anchorage (high level wall cupboard) eccentric downward loading test:</p> <p>Annex L: Photo shows heavyweight downward loading (high level wall cupboard) test in progress.</p>
<p>Photo 30.</p>

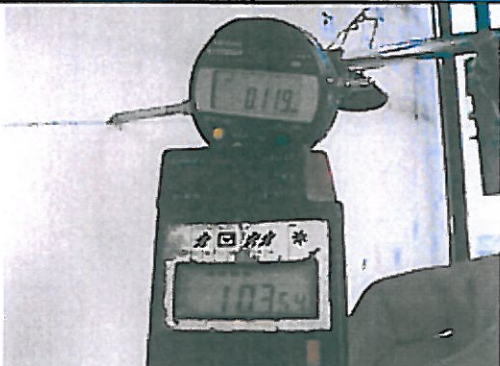
<p>Performance Testing – Heavyweight anchorage (high level wall cupboard) eccentric downward loading test:</p> <p>Annex L: Gauge reading at front wall shows deflection at 1.2m height as 0.119 mm at a load of 2000N.</p>

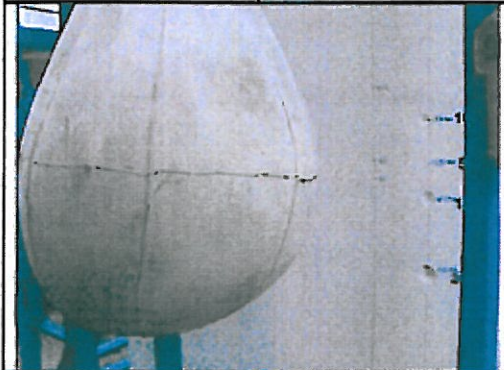
Photo 31.

<p>Performance Testing:</p> <p>Annex C – Resistance to damage by impact from a large soft body.</p> <p>No damage occurred at the junction wall.</p>
Photo 32.

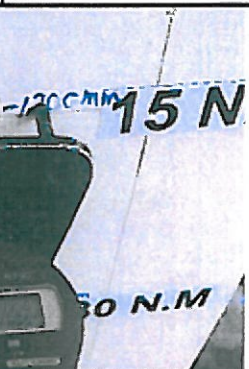
<p>Performance testing – Surface Damage (Annex B) and Perforation Test (Annex D) :</p> <p>Instrument for depth of indentation measurement at the junction wall.</p>
Photo 33.

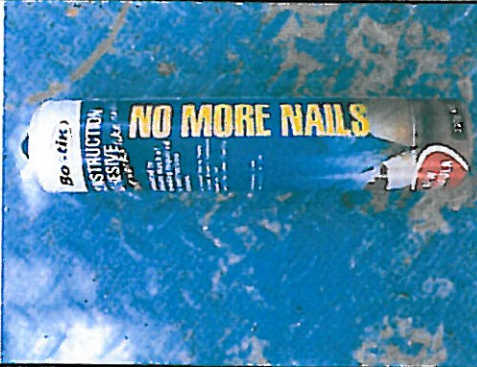
Photo 34.

<p>Bostik fireban polyurethane sealant / Construction Adhesive (320g) used as jointing material between panels.</p>
Photo 35.

<p>Installation of the first piece "Besta" MgO sandwich perlite wall panel onto the impact and robustness test frame on 30/07/2008.</p> <p>"Bostik" fireban polyurethane sealant / Construction Adhesive (320g) applied as jointing material between panels. See photo 34 in Appendix C.</p>
Photo	3.

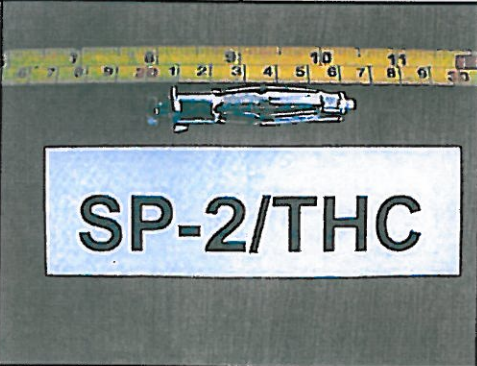
<p>Type of anchorage used: Hilti HLC sleeve anchor.</p> <p>Size of anchors: Ø 6mm x 60 mm long used in conjunction with wash basin and high level wall cupboard tests.</p>

Sample Reference	100mm sandwich MgO + Perlite + MgO wall panel
Date of test	16/07/2008
Temperature / R.H at test	33°C / 54 %
Type of Anchor	Hilti HLC Sleeve anchor (see photo 35 in Appendix C attached)
Size of Anchor	ØM6 x 60 mm long
Load (N)	100
Observations	Pull-up shim plate intact during the test. No reduction in its 20N upward force.

Sample Reference	100mm sandwich MgO + Perlite + MgO wall panel
Date of test	16/07/2008
Temperature / R.H at test	33°C / 54 %
Type of Anchor	Hilti HLC sleeve anchor (see photo 35 in Appendix C attached)
Size of Anchor	Ø M6 x 60 mm long
Load (N)	250
Observations	Pull-up shim plate intact during the test. No reduction in its 20N upward force. Maximum displacement of pull-down test bracket is 0.26 mm.

Sample Reference	100mm sandwich MgO + Perlite + MgO wall panel				SS 492 : 2001 Performance Requirements
Type of Anchor	Hilti HLC Sleeve Anchor (see photo 35 in Appendix C attached)				-
Size of Anchor (mm)	ØM6 x 60 mm				-
Date of test	18/08/2008				-
Temperature / R.H at test	34°C / 64%				-
Deflection measuring points : Pt.1 at 1.20m; Pt.2 at 1.75m	Front		Back		-
	1	2	1	2	-
Maximum deflection (mm) at :	500 N	0.04	0.27	0.38	5 mm max.
	1000 N	0.09	0.54	0.69	20 mm max.
Residual deformation (mm)	500 N	0.02	0.16	0.15	1 mm max.
	1000 N	0.11	0.08	0.01	1 mm max.
Highest load sustained (N)	up to 1000				-

Sample Reference		100mm sandwich MgO + Perlite + MgO wall panel				SS 492 : 2001 Performance Requirements
Type of Anchor		Hilti HLC Sleeve Anchor (see photo 35 in Appendix C attached)				-
Size of Anchor (mm)		ØM6 x 60 mm				-
Date of test		17/07/2008				-
Temperature / R.H at test		29°C / 52%				-
Deflection measuring points : Pt.1 at 1.20m; Pt.2 at 1.75m		Front		Back		-
		1	2	1	2	-
Maximum deflection (mm)	2000 N	0.10	0.58	0.13	0.07	15 mm max.
Residual deformation (mm)	2000 N	0.10	0.56	0.05	0.04	1 mm max.
Highest load sustained (N)		Up to 2000				-
